## 5.0 Falls City, Texas, Disposal Site

### 5.1 Compliance Summary

The Falls City Disposal Site, inspected on January 14, 2004, was in good condition. Maintenance items included continued grass management, and control of small trees and shrubs growing in the riprap on the side slopes. Results of ground water monitoring were consistent with results from previous years and indicate essentially steady-state conditions. No cause for a follow-up or contingency inspection was identified.

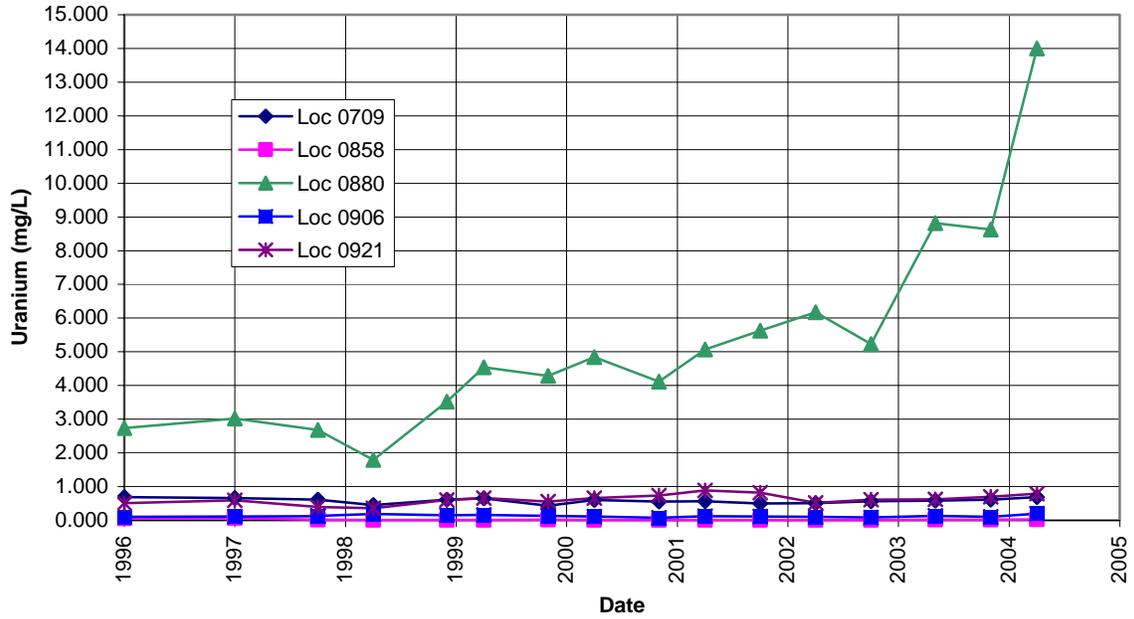
Figure 5-5. Uranium in Ground Water at Cell Performance Monitoring Locations at the Falls City, Texas, Disposal Site

Uranium concentrations in ground water in the vicinity of the disposal cell are consistent with the previous sampling event. The concentration in monitor well MW-0880 continues to be substantially greater than the other wells and continues to increase (Figure 5-5). The increase may be an indication of seepage from the disposal cell, as expected; there is no risk, however, because ground water is not used in the area. As shown on Figure 5-6, uranium in ground water in the compliance monitoring network has varied substantially in two wells (MW-0891 and MW-0924) since 1997 and exceeded the maximum concentration limit of 0.044 mg/L in four wells (MW-0886, MW-0891, MW-0924, and MW-0963). The increasing trend in uranium concentration in MW-0924 cannot be attributed to degradation of the cell because the wells between it and the cell continue to have low concentrations.

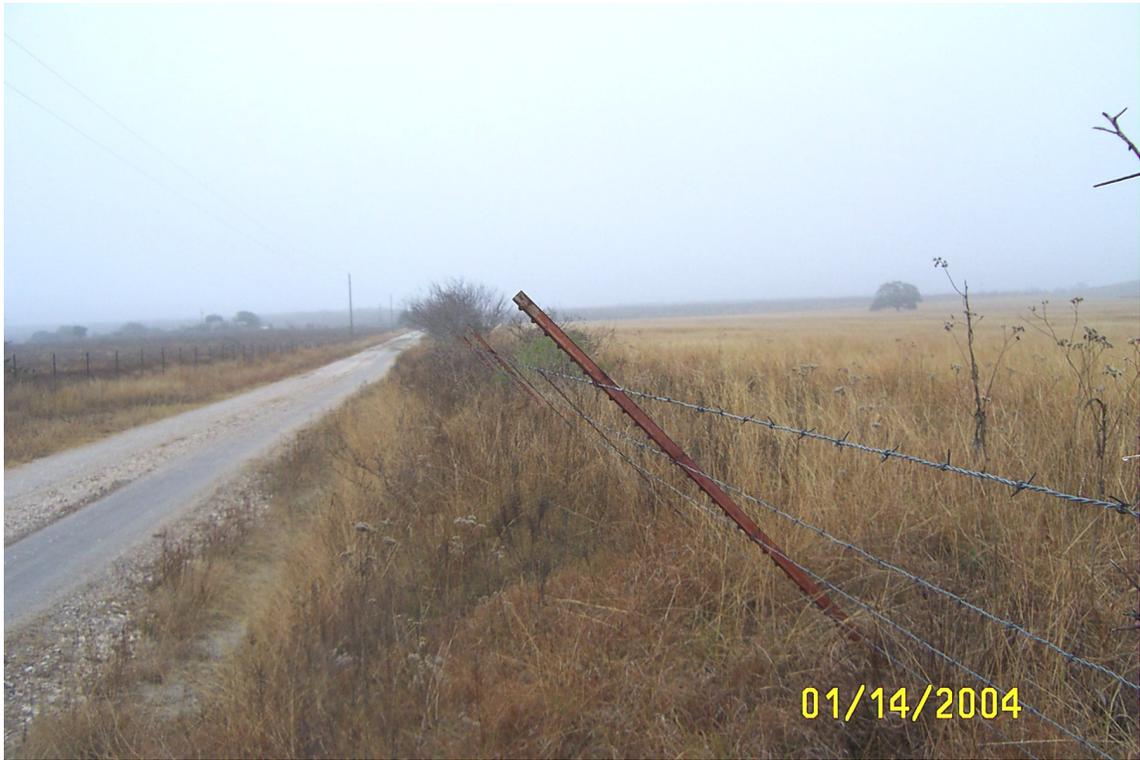
**Access Road, Entrance Gate, Fence, and Signs**—Access to the site is through a vehicle gate directly off of a public right-of-way (Farm-to-Market Road 1344). The main entrance gate and another vehicle gate on the same side of the property were locked and in excellent condition. A barbed-wire fence, set on the property boundary, was in generally good condition. It leans outward above a steep bank along the northwest boundary, but is stable in this position and is

sufficient to keep cattle and casual intruders out (PL-1). The fence predates cell construction and requires occasional repairs of broken strands, and eventually will need to be replaced.

*FCT 1/2004. PL-1. Section of perimeter fence leaning outward, located near perimeter sign P38 along County Road 202.*

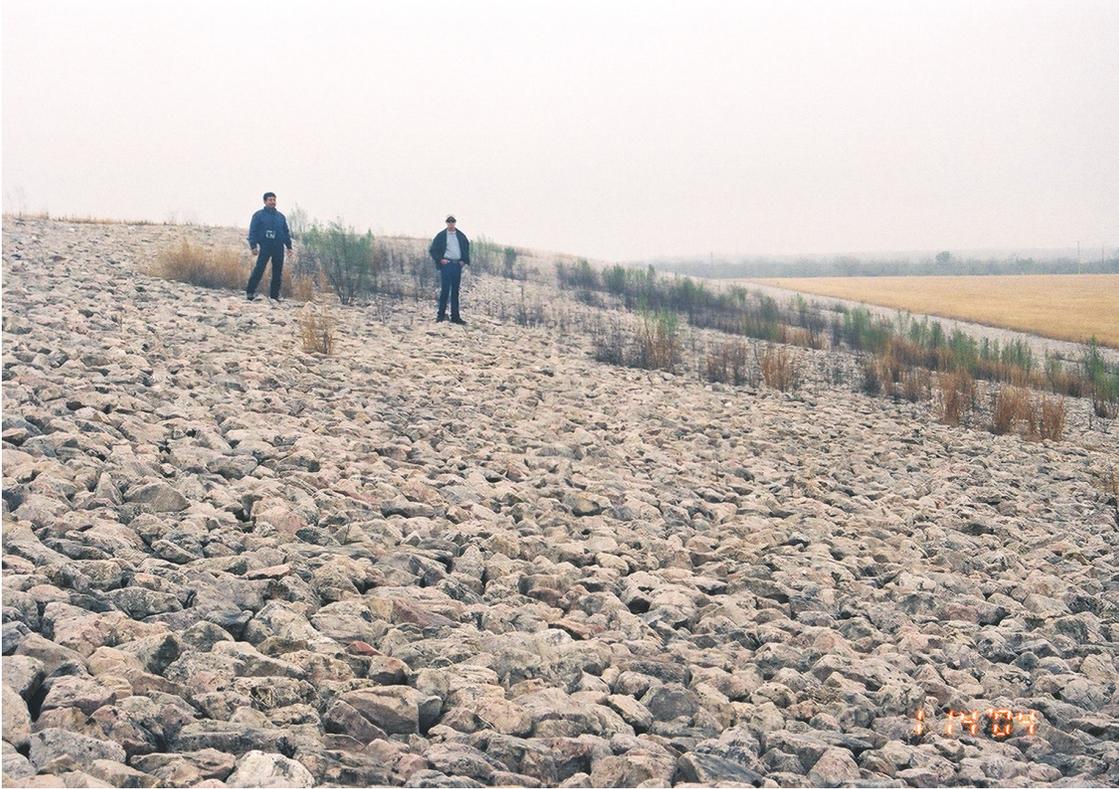
Trees and woody shrubs, including deep-rooted greasewood, tend to establish on the side slopes and require periodic removal. Patches of these plants were present at the time of the inspection with some plants measuring 7 feet tall (PL-2). The trees and shrubs were cut down and herbicide was applied to their stems.

*FCT 1/2004. PL-2. Typical vegetation growth found on the side slopes of the disposal cell.*
