## 5.0 Falls City, Texas, Disposal Site

### 5.1 Compliance Summary

The Falls City Disposal Site, inspected on January 14, 2004, was in good condition. Maintenance items included continued grass management, and control of small trees and shrubs growing in the riprap on the side slopes. Results of ground water monitoring were consistent with results from previous years and indicate essentially steady-state conditions. No cause for a follow-up or contingency inspection was identified.

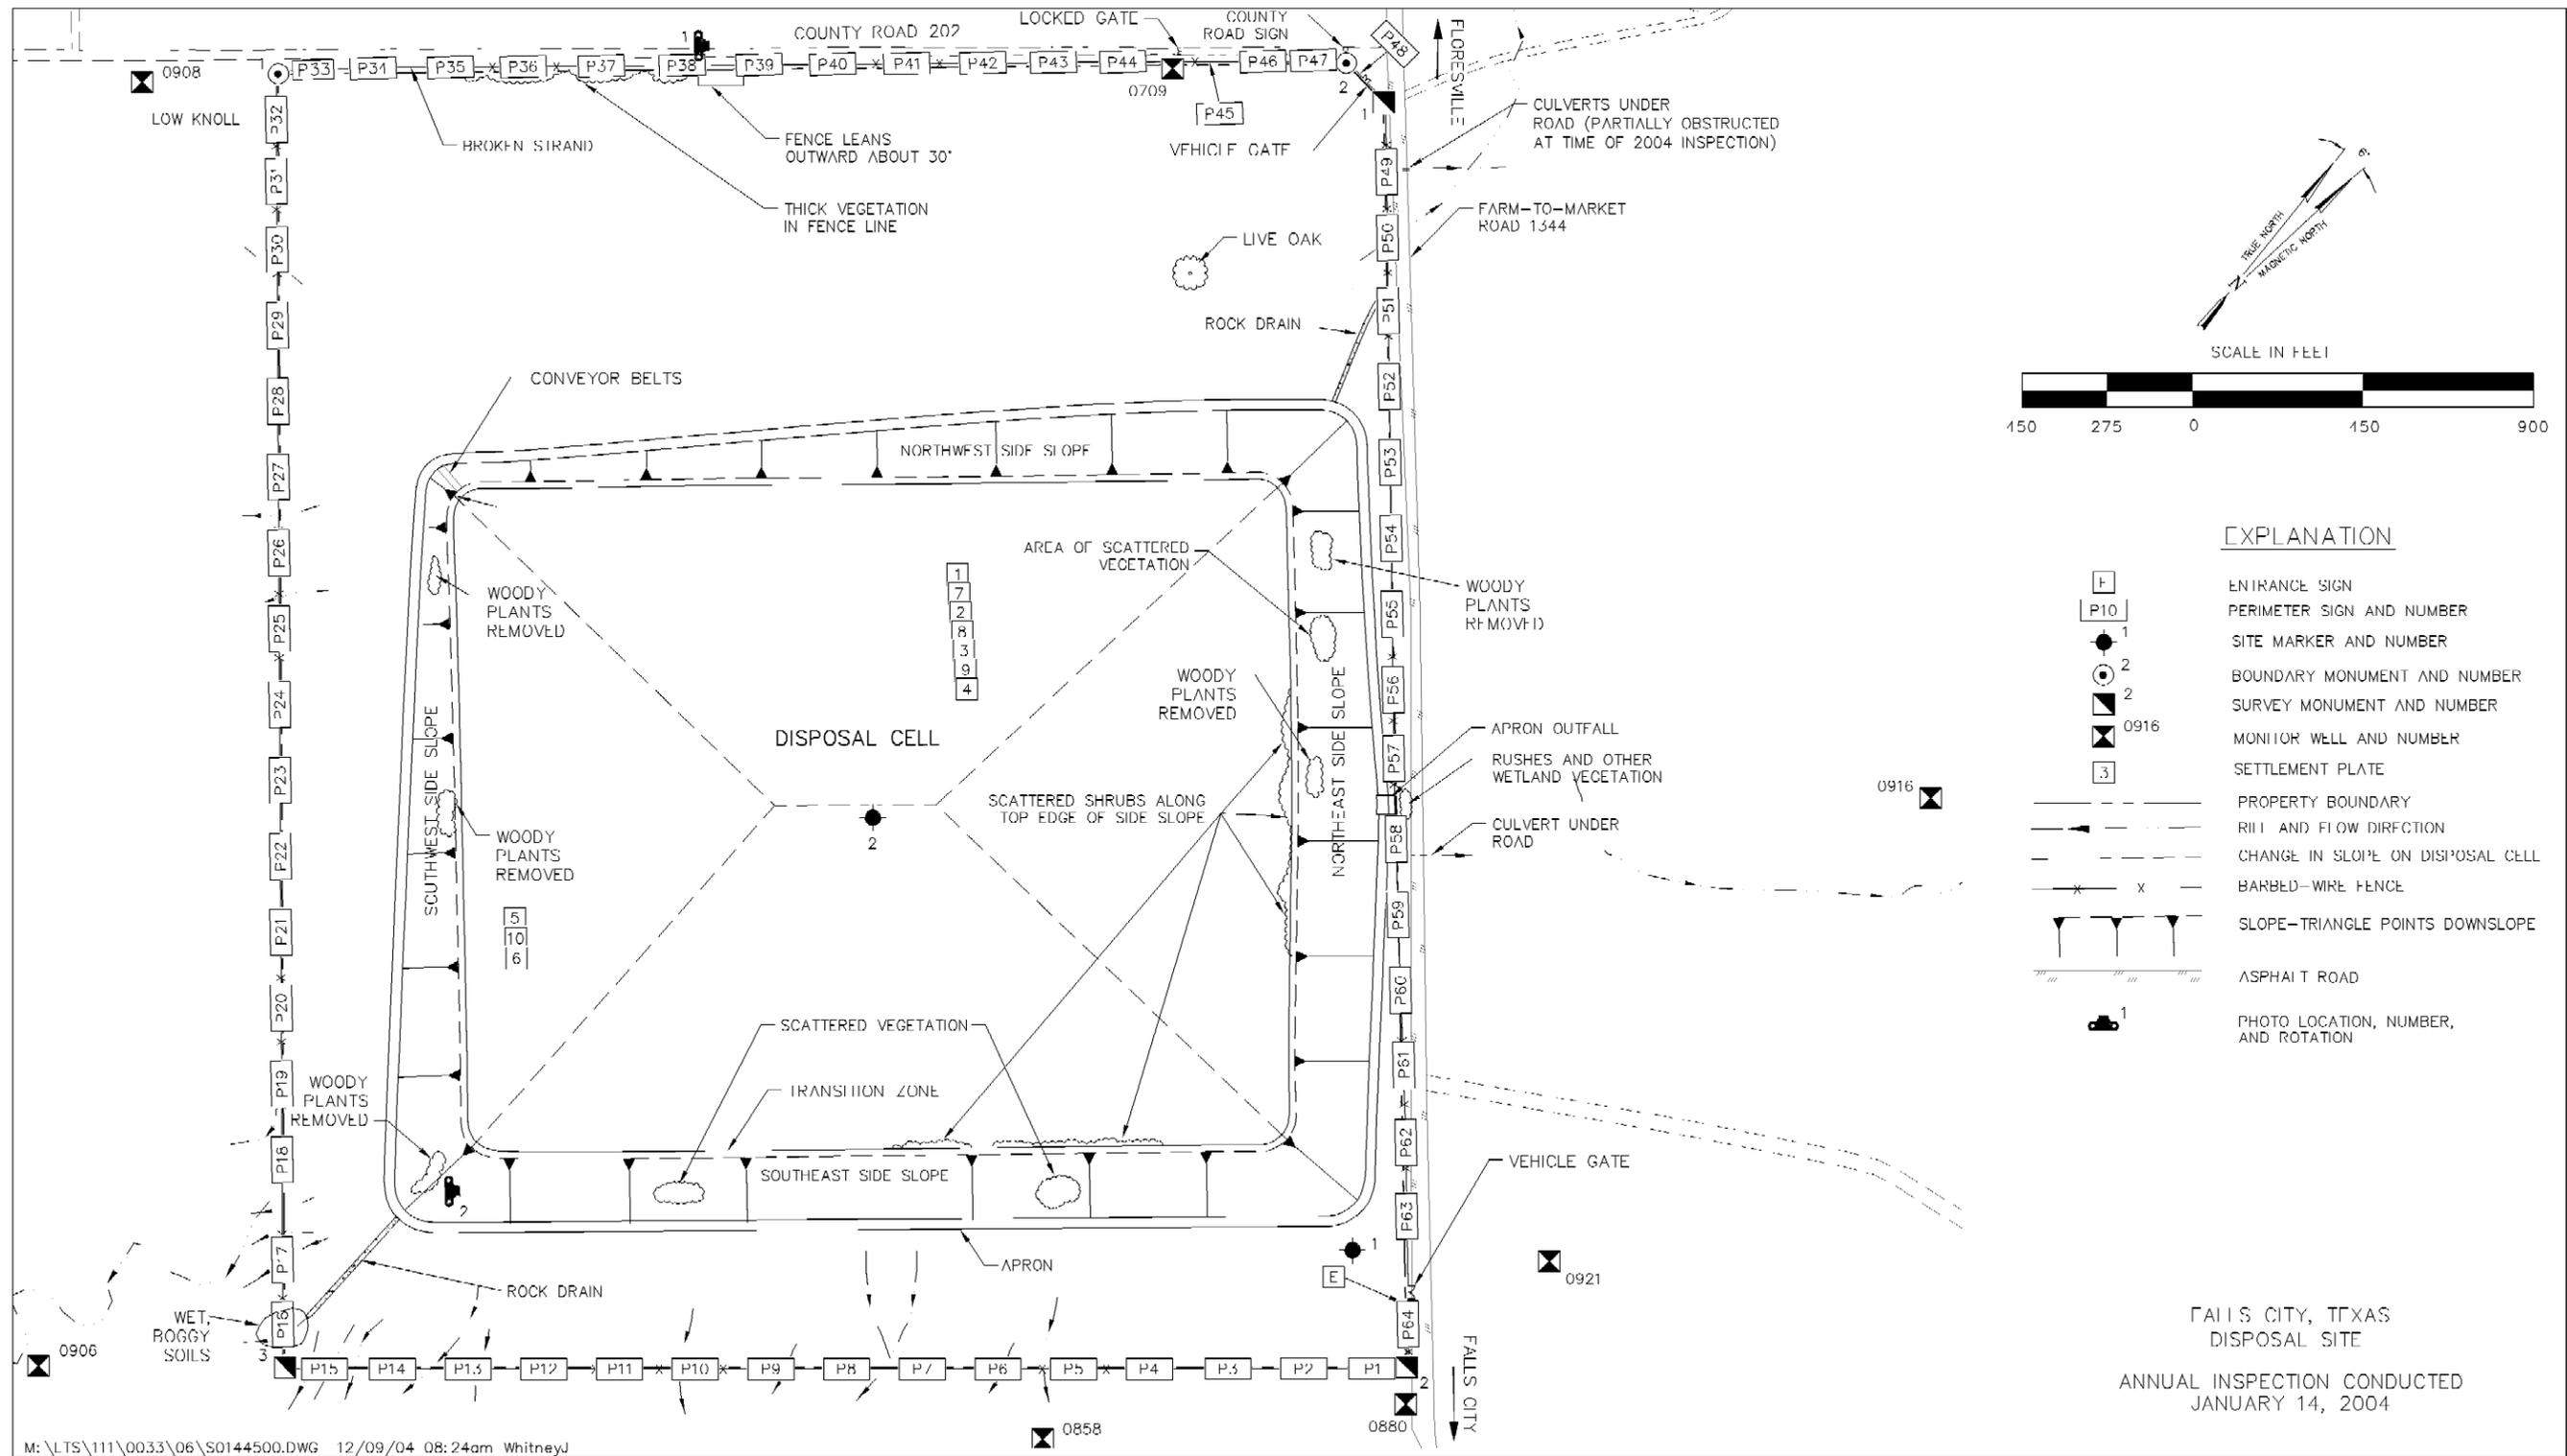
Figure 5-1. 2004 Annual Compliance Drawing for the Falls City, Texas, Disposal Site

**Access Road, Entrance Gate, Fence, and Signs**—Access to the site is through a vehicle gate directly off of a public right-of-way (Farm-to-Market Road 1344). The main entrance gate and another vehicle gate on the same side of the property were locked and in excellent condition. A barbed-wire fence, set on the property boundary, was in generally good condition. It leans outward above a steep bank along the northwest boundary, but is stable in this position and is

sufficient to keep cattle and casual intruders out (PL-1). The fence predates cell construction and requires occasional repairs of broken strands, and eventually will need to be replaced.

Trees and woody shrubs, including deep-rooted greasewood, tend to establish on the side slopes and require periodic removal. Patches of these plants were present at the time of the inspection with some plants measuring 7 feet tall (PL-2). The trees and shrubs were cut down and herbicide was applied to their stems.

No water was observed flowing in either the north or the south rock drains. Although no flow was observed at the time of the inspection, water had recently drained from the south rock drain, as indicated by saturated soils at the drain outfall. Grass growing in both drains has not historically impeded the flow of water draining from the cell. The apron outfall, midway along the northeast side slope, is not yet affected by grass encroachment. Grass in the rock drains may actually assist in dissipating the energy of site runoff, and may, therefore, be a desirable feature.

One of the three large culverts that extend beneath the Farm-to-Market Road 1344 near perimeter sign P49 was partially obstructed with sediment and weed accumulation. Although there is no evidence that runoff water has been blocked or obstructed in the past, this location will continue to be monitored and appropriate maintenance actions will be conducted as necessary to prevent runoff water from backing up and flooding within the site boundary.

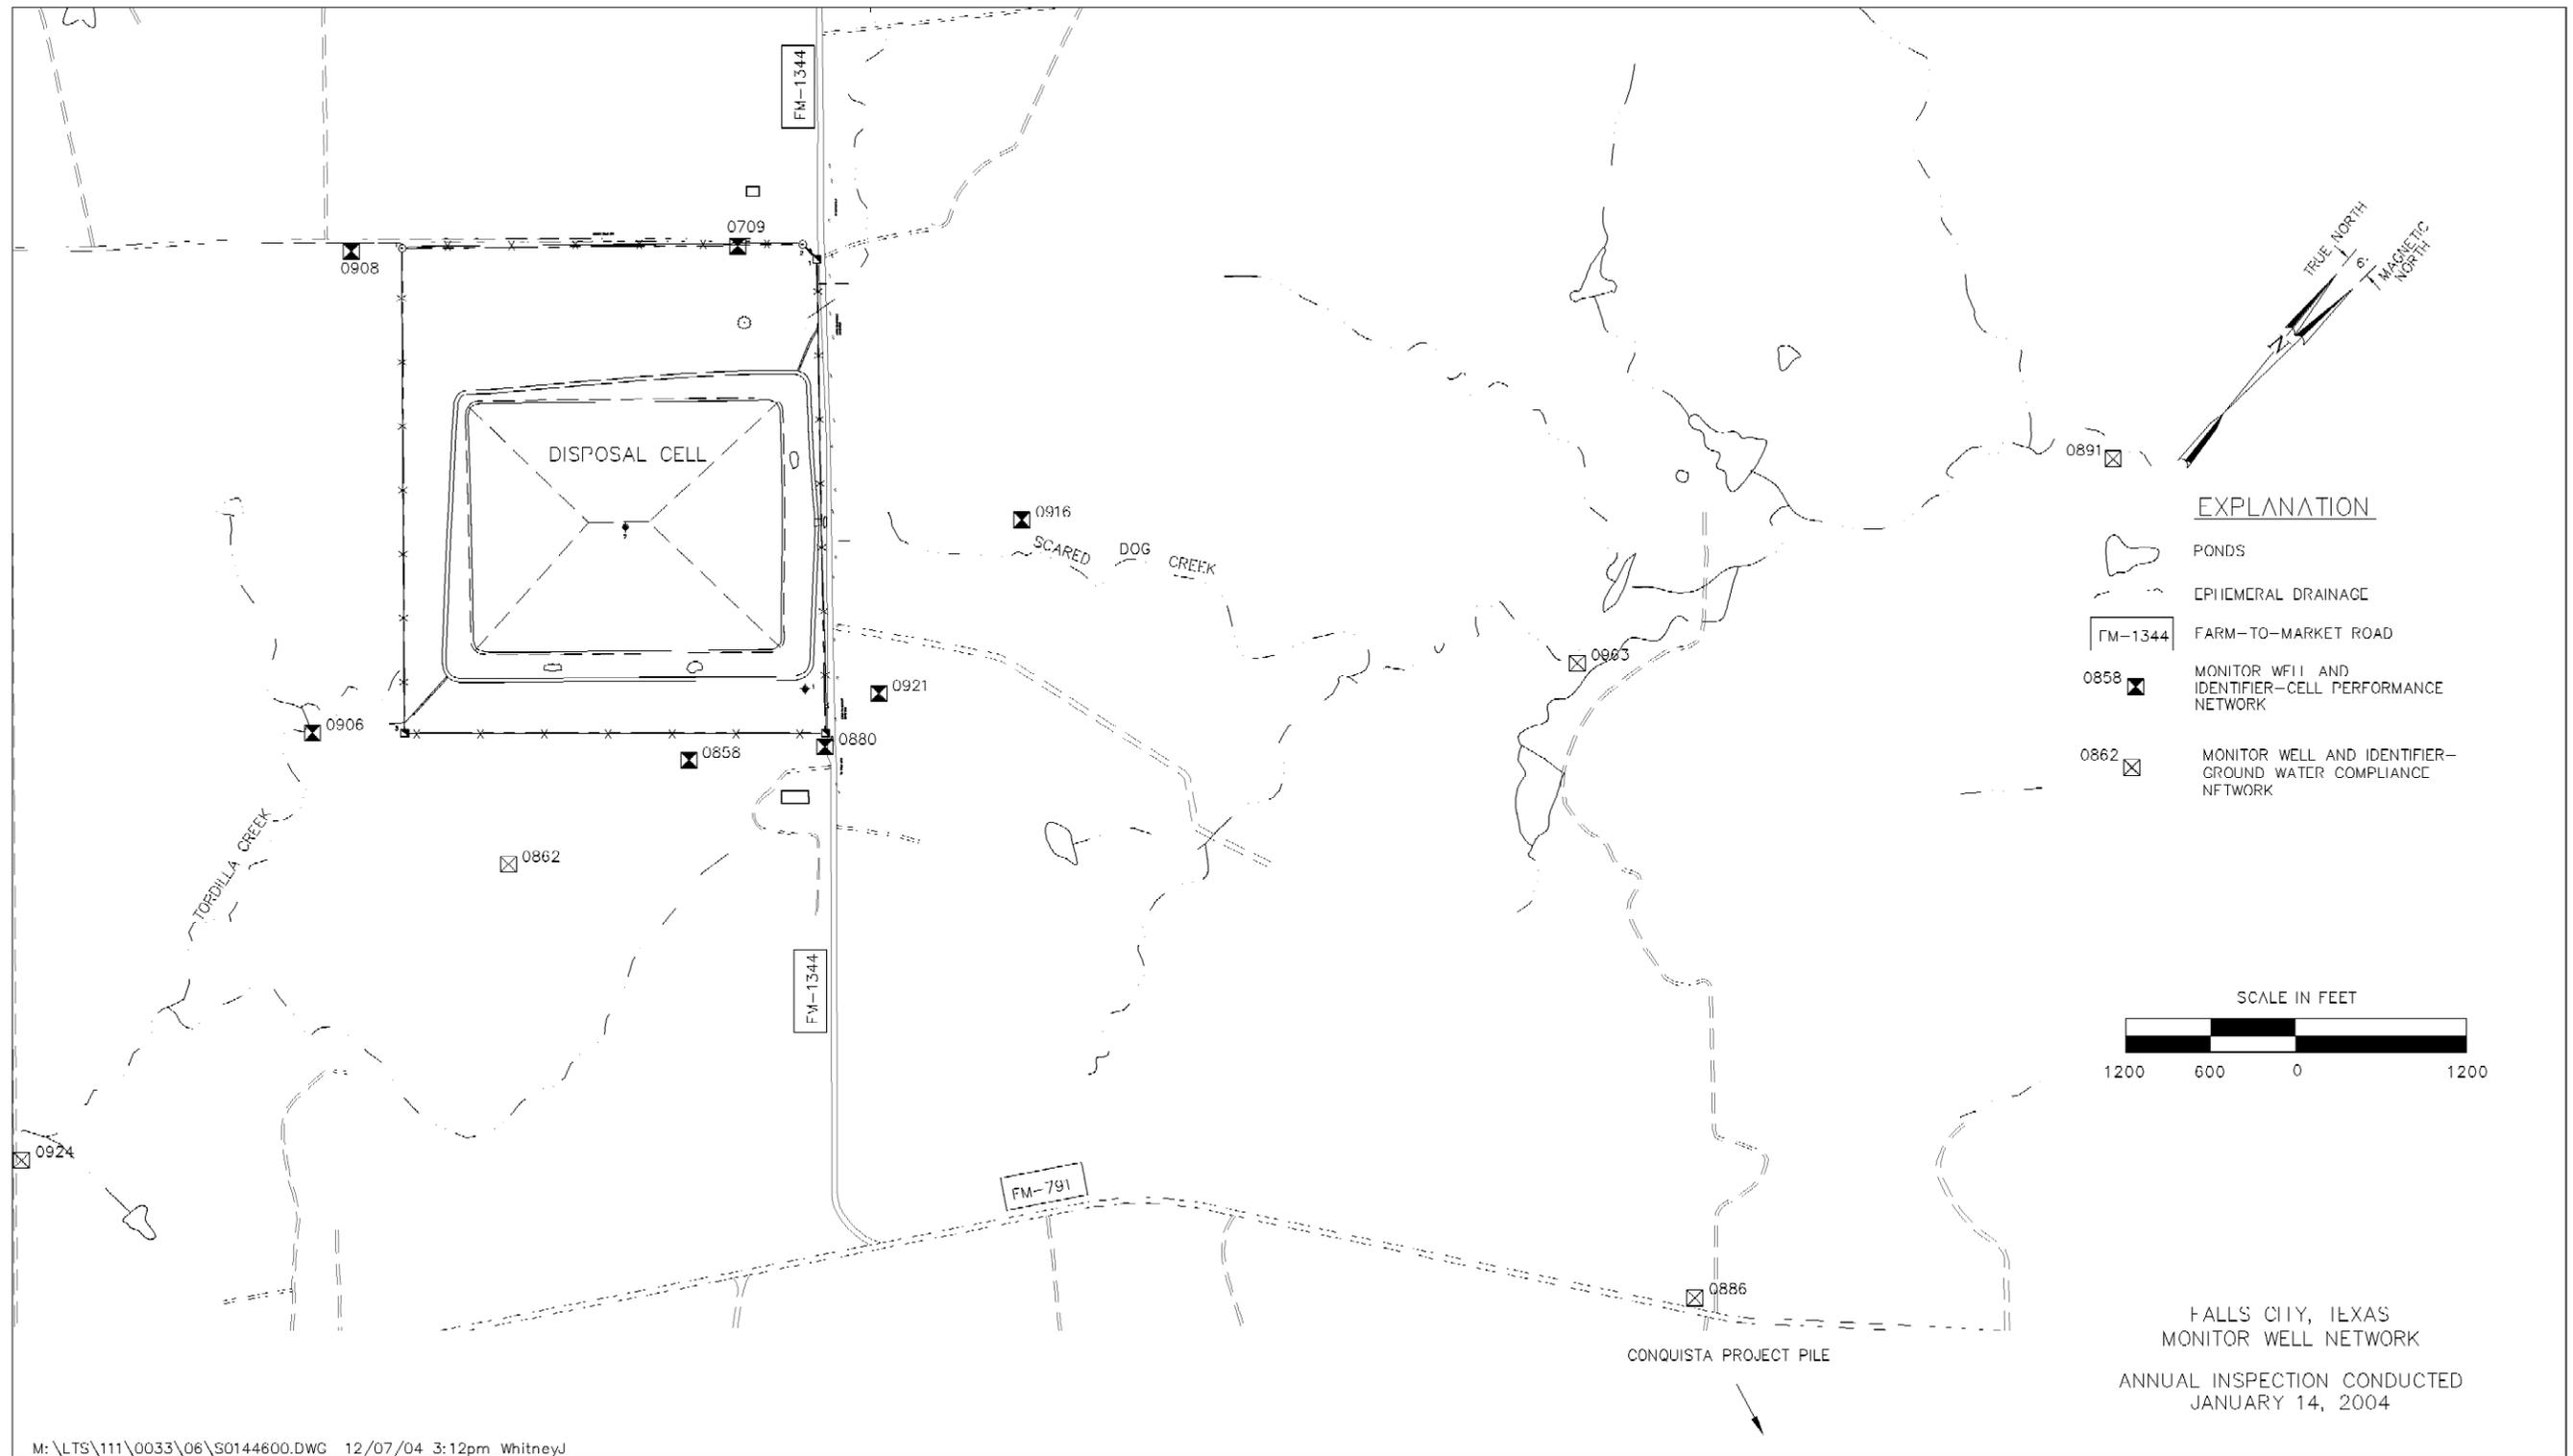
Figure 5-2. Monitor Well Network at the Falls City, Texas, Disposal Site

The disposal cell performance monitoring network consists of five monitor wells (MW-0709, MW-0858, MW-0880, MW-0906, and MW-0921) that are sampled semiannually as specified in the LTSP. Two additional cell performance wells (MW-0908 and MW-0916) were designated for water level measurements only. The ground water compliance monitoring network consists of five monitor wells (MW-0862, MW-0886, MW-0891, MW-0924, and MW-0963) that are sampled annually as specified in the GCAP. Ground water samples from the ten monitor wells are analyzed for 33 constituents, including ten which have maximum concentration limits specified in Table 1 to Subpart A of 40 CFR 192. The LTSP identifies pH levels in ground water as the indicator for disposal cell performance on the basis of tailings pore-fluid chemistry. It was anticipated that changes in pH could be used to predict changes in uranium concentrations. The monitor well network is shown on Figure 5-2.

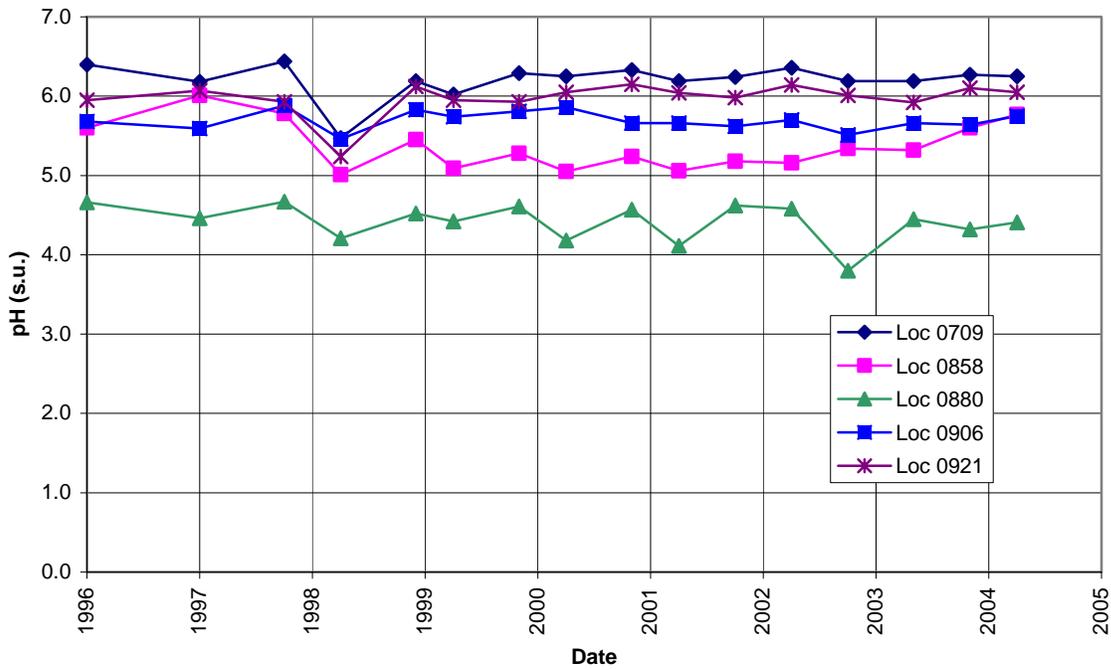
Figure 5-3. pH in Ground Water at Cell Performance Monitoring Locations at the Falls City, Texas, Disposal Site

Analytical results from 2004 are generally consistent with previous results and what would be expected of ground water conditions in a naturally mineralized area that has been impacted by uranium exploration and mining activities. Levels of pH have not varied significantly (Figures 5-3 and 5-4). Analyses of all pH and uranium sample results indicate that there is no statistical correlation between changes in pH and changes in uranium in any of the monitor wells.

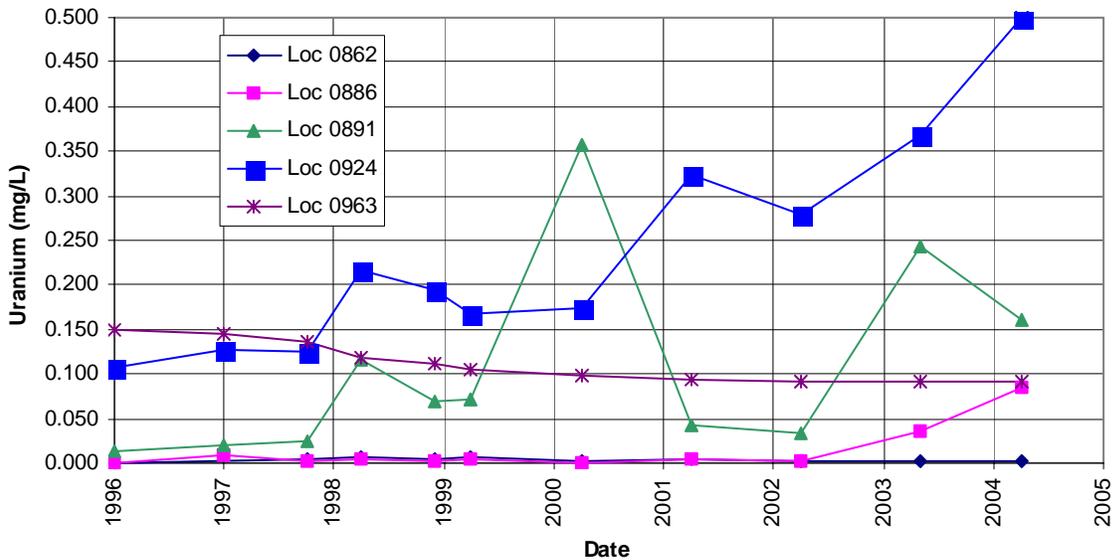
Figure 5-6. Uranium in Ground Water at Compliance Monitoring Locations at the Falls City, Texas, Disposal Site

Uranium concentrations in ground water in the vicinity of the disposal cell are consistent with the previous sampling event. The concentration in monitor well MW-0880 continues to be substantially greater than the other wells and continues to increase (Figure 5-5). The increase may be an indication of seepage from the disposal cell, as expected; there is no risk, however, because ground water is not used in the area. As shown on Figure 5-6, uranium in ground water in the compliance monitoring network has varied substantially in two wells (MW-0891 and MW-0924) since 1997 and exceeded the maximum concentration limit of 0.044 mg/L in four wells (MW-0886, MW-0891, MW-0924, and MW-0963). The increasing trend in uranium concentration in MW-0924 cannot be attributed to degradation of the cell because the wells between it and the cell continue to have low concentrations.
